**KOMITE NASIONAL KESELAMATAN TRANSPORTASI  
REPUBLIC OF INDONESIA**

## **KNKT.21.01.01.04**

### **Aircraft Accident Investigation Report**

**PT Sriwijaya Air**  
**Boeing 737-500; PK-CLC**  
**Kepulauan Seribu District, DKI Jakarta**  
**Republic of Indonesia**  
**9 January 2021**

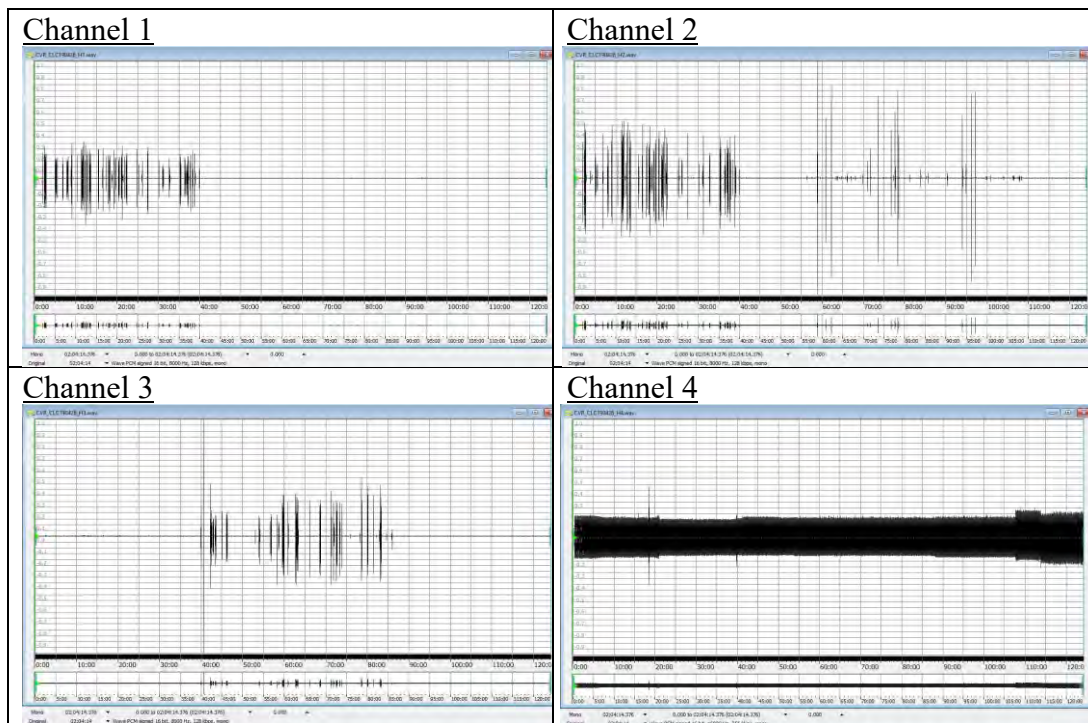
The CVR P/N 2100-1020-00 with S/N 000286507 data was downloaded in 2019 and 2020 for the renewal of the Certificate of Airworthiness (C of A) which in 2019, the CVR download was performed at the Garuda Maintenance Facility. The downloaded audio from the Channels 1, 2 and 3 were normal while the Channel 4 recorded a prominent tone with a frequency of about 400 Hz. The result of the download stated that the CVR was functioning correctly.

**Figure 14: The downloaded CVR data in 2019**

The investigation was unable to determine the reason on why Channel 4 recorded a prominent tone with a frequency of about 400 Hz in the downloaded CVR data in 2019 but was not in the downloaded CVR data in 2020.

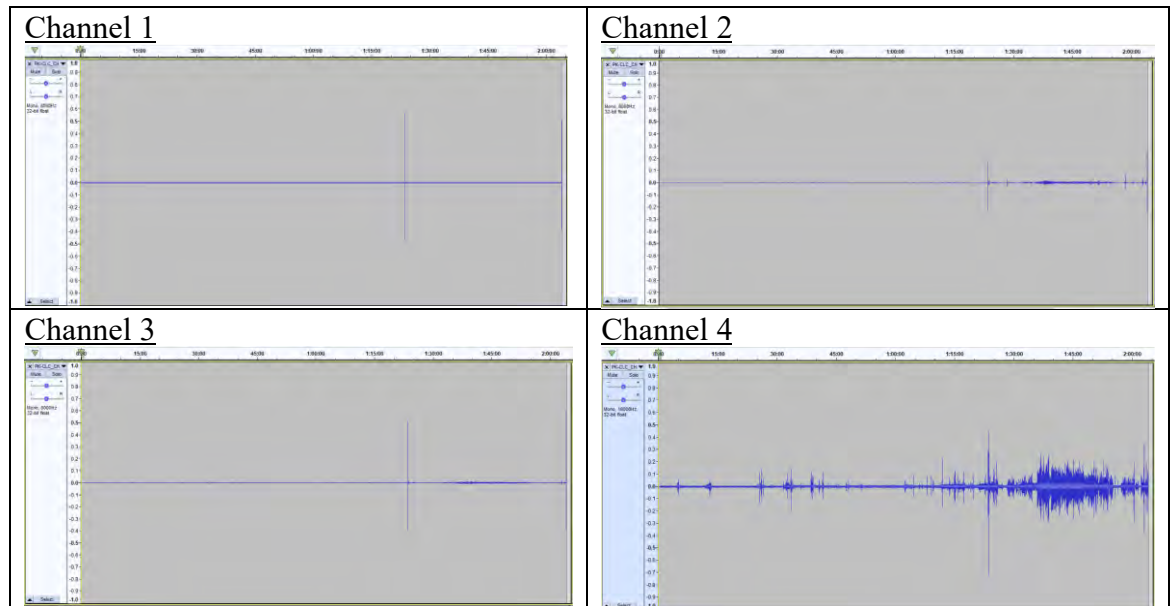
On 9 April 2020, the CVR was downloaded at the Sriwijaya Air facility while the aircraft was grounded for maintenance. There was no recording on Channels 1, 2 and 3, while Channel 4 recorded conversation between engineers while performing maintenance. The result of the download stated that the CVR was functioning correctly.

**Figure 15: The downloaded CVR data in 2020**

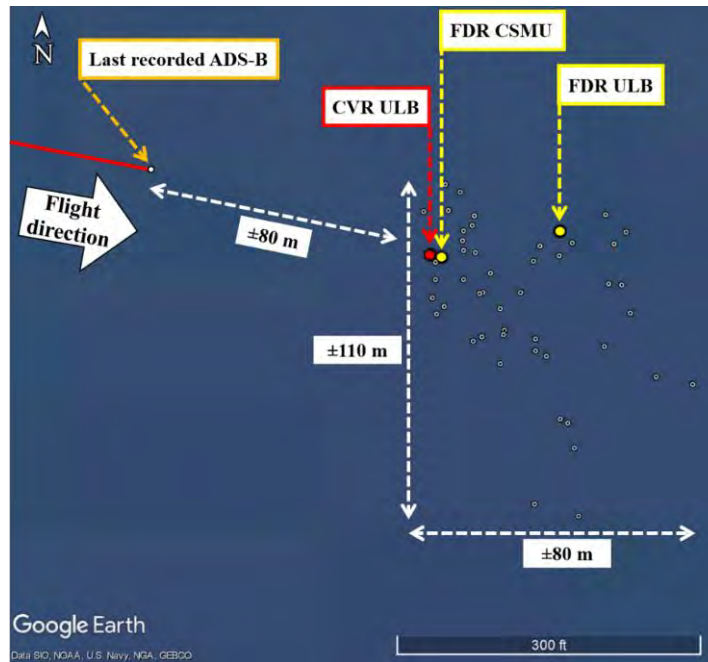
**Figure 17: Location of FDR CSMU, FDR ULB and CVR ULB relative to the last ADS-B recorded data**

The FDR's CSMU was found within the wreckage distribution area at coordinates 5°57'51.00" S 106°34'31.00" E. The ULBs were detached from both the FDR and the CVR<sup>15</sup>. The FDR's ULB was found at coordinates 5°57'50.76" S 106°34'32.10" E approximately 35 meters from the FDR's CSMU, and the CVR's ULB was found at coordinates 5°57'50.98" S 106°34'30.90" E.

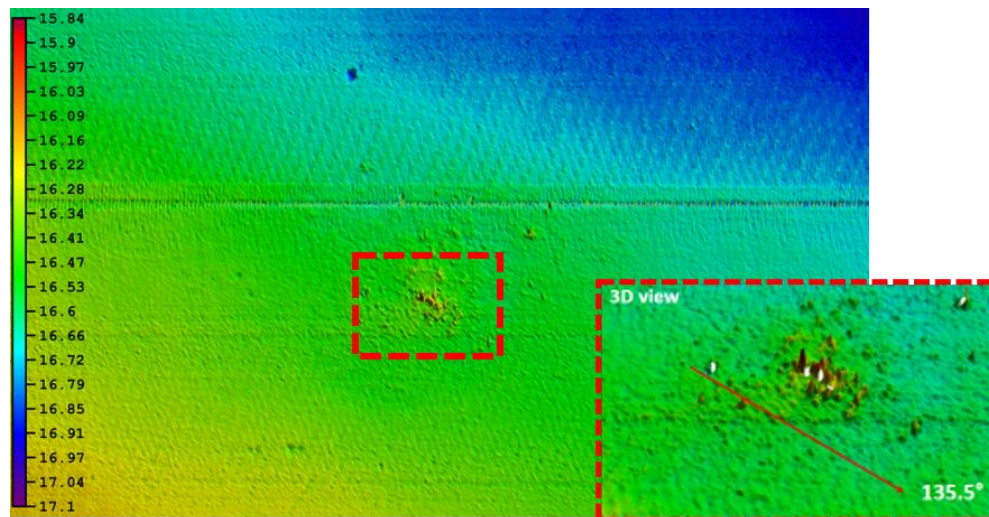
**Figure 18: Scanning result from multibeam echosounder**

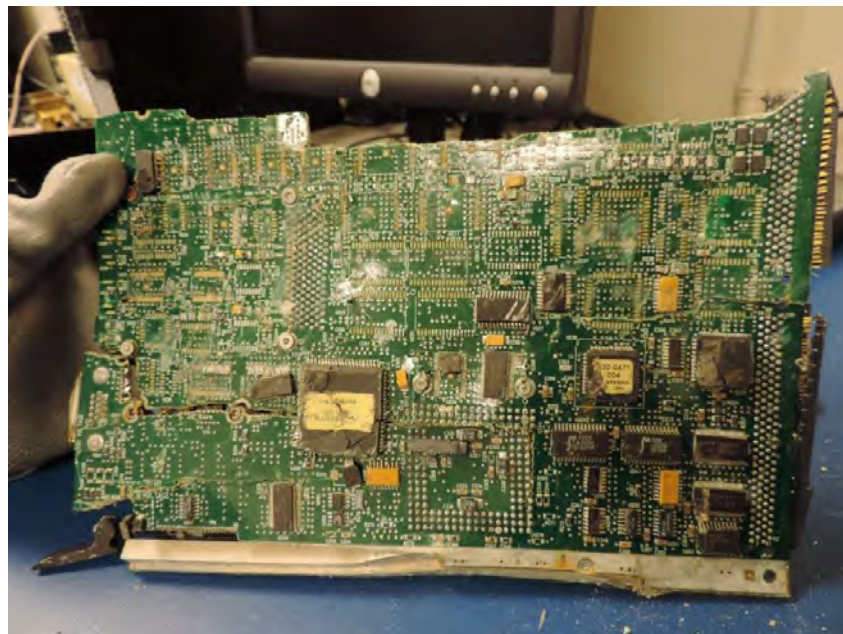
**Figure 19: The EGPWS CCA**

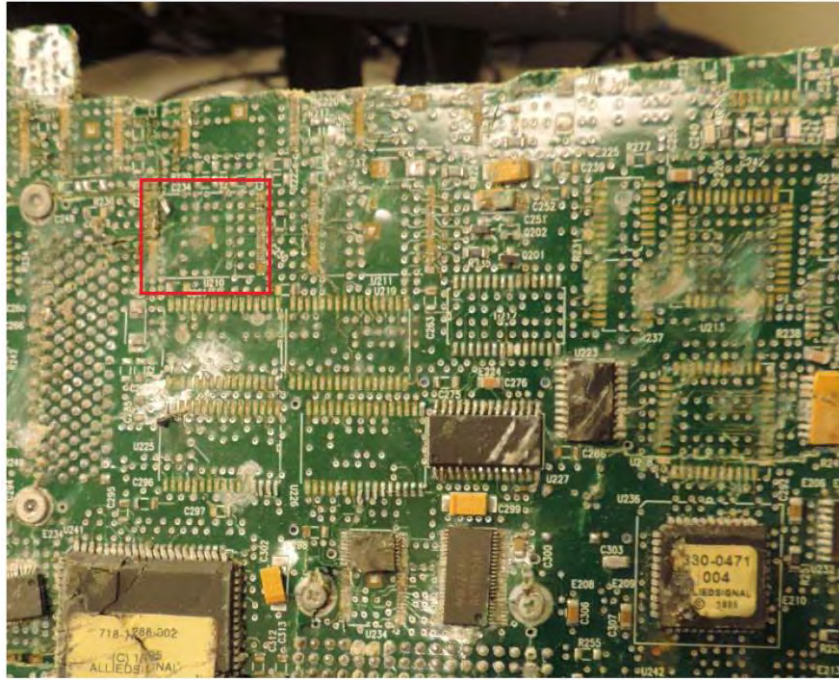
In this version of EGPWS computer, flight history data is stored in the memory chip on the controller A2 CCA. Some components were missing from the A2 CCA, including the memory chip. The location of the missing A2 CCA memory chip is shown in the following figure.

**Figure 20: The red box is to identify the missing EGPWS A2 CCA chip**

As the memory chip was not recovered, no further examination was conducted to the unit and no flight history data could be retrieved.
